UNITED STATES ENVIRONMENTAL PROTECTION AGENCY
REGION 10

Re: Fourth Avenue and Gambell Parking Lot Site
EPA Site # AKN001002925

**FOURTH AND GAMBELL SITE
VAPOR MITIGATION SYSTEM
MONITORING, MAINTENANCE, AND
REPAIR PLAN**

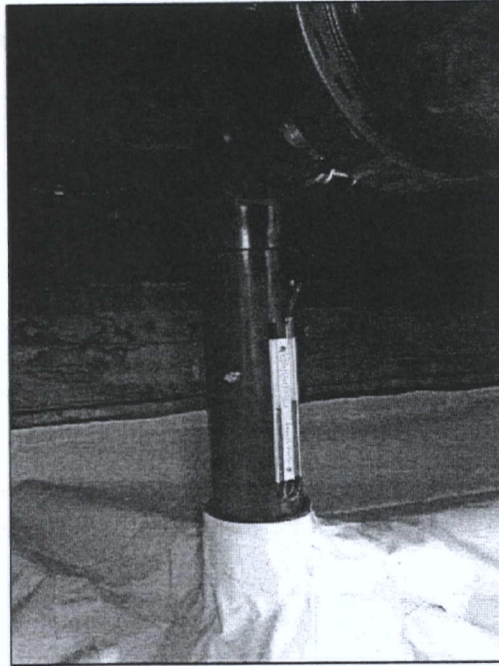
A radon style inline exhaust fan was installed on each exhaust pipe to draw contaminant vapors into the mitigation system lines and exhaust them outside the building. Analog manometers were installed on each vertical piping for monitoring the vacuum level at each location, as shown in Photograph 2:

Photograph 2: The U-shaped manometer mounted on a 4-inch vertical pipe in the crawlspace area.

fans. One side of the U-tube is connected via flexible tubing to a hole in the vertical pipes. The height of the red oil on the right-hand side of the graduated U-tube measures level of vacuum being drawn on the system in inches of water column (inWC). Any reading above 0 inWC indicates that vacuum is being drawn through the line and the system is working. **If the red oil on the right side of the manometer drops to zero, the owner should contact the designated environmental contractor to investigate the failure of the system.**
